Road Safety Study during Construction Work of an at Grade Intersection Converting it to a Flyover

Abstract: A flyover was constructed for solving the traffic problems, to improve the traffic flow at an intersection, to reduce the delays and accidents. 25 traffic accidents occurred during the construction work. This study will point out the issues that might be the cause of all these accidents around the construction area and in the conclusion the data of road safety evaluation (accident costs) will be shown.

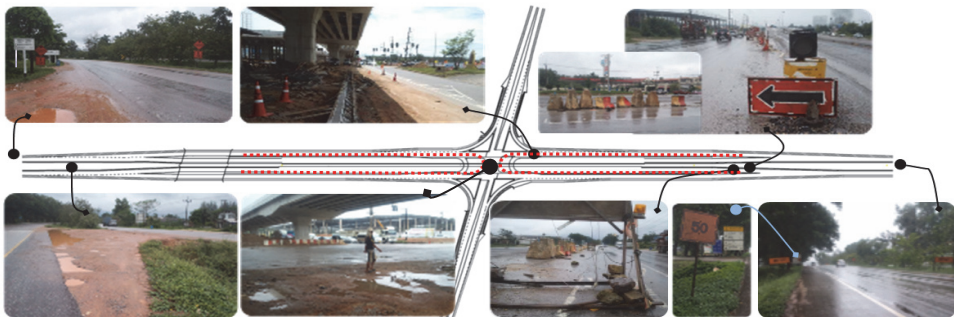
Figure 5. Traffic management issues

The picture of traffic management issues are shown in Figure 5

- The temporary traffic signs were installed at inappropriate locations,
- Did not have the staff to protect 2 zones,
- Auditor found only one of the speed limit signs (50 km/h); it was installed on the HW route 43 before entry to intersection 300 meters,
- Concrete blocks did not cover the construction zone, they did not protect the road users and construction zones, on the contrary, they raised problems for the road users because of their different sizes and, installed at inappropriate locations,
- Street lights according to the guideline of road lane direction were not turned on every night, and
- Road sections and construction zones were not divided clearly, so vehicles could enter and cross construction zones.

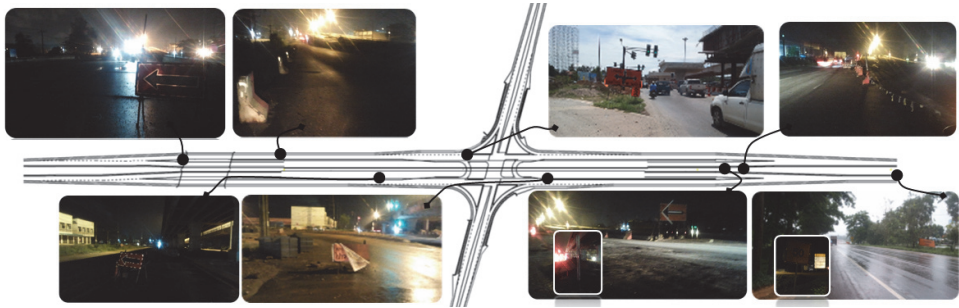
Figure 6. Traffic signs and road marking issues

The pictures of traffic signs and road marking issues are shown in Figure 6

- The installation of temporary traffic signs was not stable, not enough and insufficient,
- Traffic signs were not reflective at night and some traffic signs were damaged,
- Background (brown) and text (black) in traffic signs could not be seen clearly,
- There were traffic signs with different characteristics, and
- Road markings at intersection could not be seen clearly.

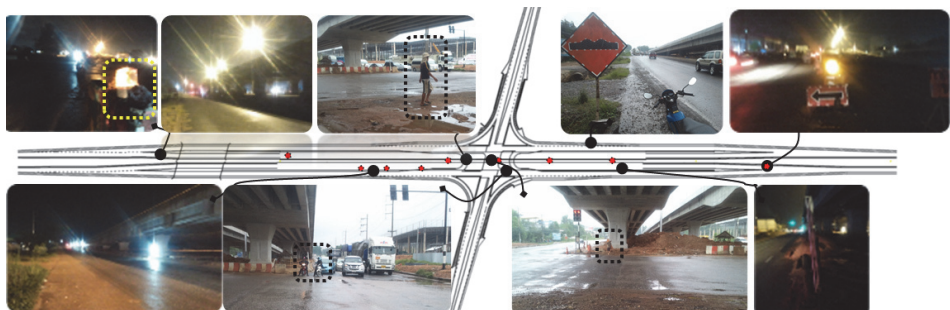
Figure 7. Pedestrians, bicycles and road surface issues

The pictures of pedestrians and bicycle issues are shown in Figure 7

- There were no stopping lines for motorcycles and bicycles at the intersection,
- There were scraps on the shoulder of the road, the bicycle cannot bike on this area, and
- There were loose aggregates that reduce skid resistance around this construction zone.

The pictures of road surface issues are shown in Figure 7

- Road surface was not smooth and bumpy,
- There was water covering the surface of road after rain, and
- Mud mound, soil, and raw aggregates were found on the sidewalk and on the shoulder.

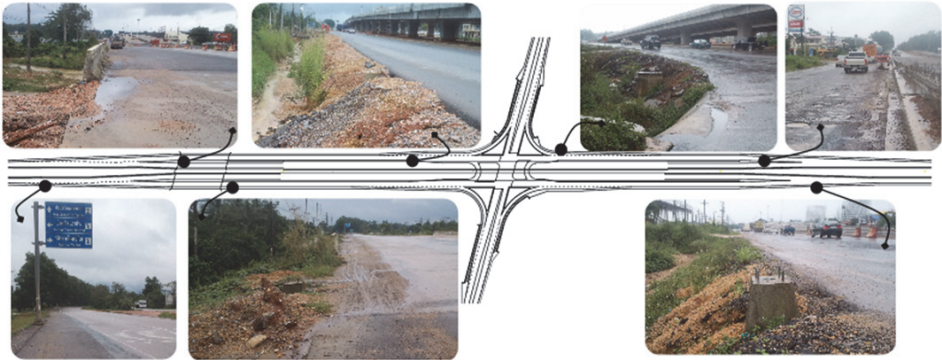
Figure 8. Other issues

The pictures of other issues are shown in Figure 8

- There were no energy absorbing devices at the edge of the river bridge,
- There were no guardrails or concrete blocks between the road surface and roadside area to prevent the vehicles from falling down the road, and
- There were fixed rigid objects near the road surface.

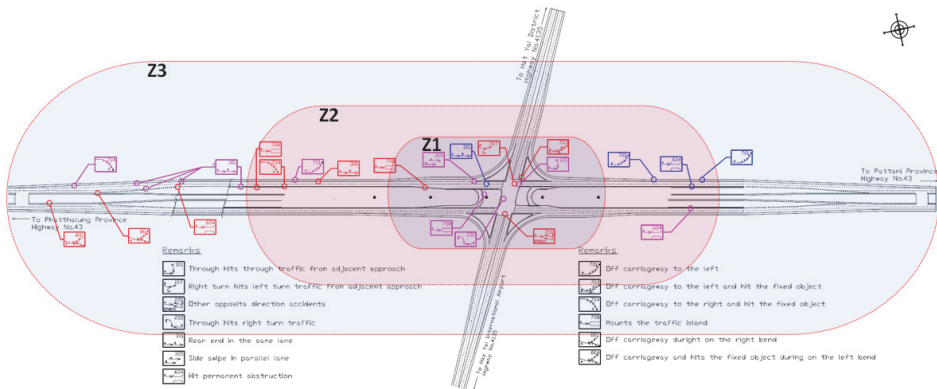
Figure 10. Spot of accident at intersection area and collision diagram

All of the 25 accidents where the data on the spot of accident and time of the accident are consistent with the time of management of each zone are shown in Figure 10. Accident costs were calculated as follows;

Accident: 25 times/ 929 days (Z1: 9, Z2: 9, Z3: 7)

Time of Accident				Number of Casualty			Property Damage Only
Dry		Wct		Injury	Serious	Died	
Day	Night	Day	Night				
8	11	6	-	20	6	6	1,353,900
