Hazardous Situations and Accidents Caused by Light and Medium Unmanned Free Balloon Flights

- Abstract: The article deals with the presentation and analysis of hazardous situations, damage events and accidents caused by light and medium unmanned free balloons and the parts of them. During the flights of these balloons, emergencies, hazardous situations, and accidents can occur in many different ways. Hazardous situations and damages at the process of landing and after it have also many different variations. At the end of the article we draw conclusions based on the previous analyzes.
- *Keywords: unmanned free balloon; hazardous situation; damage; accident; tracking; structure*

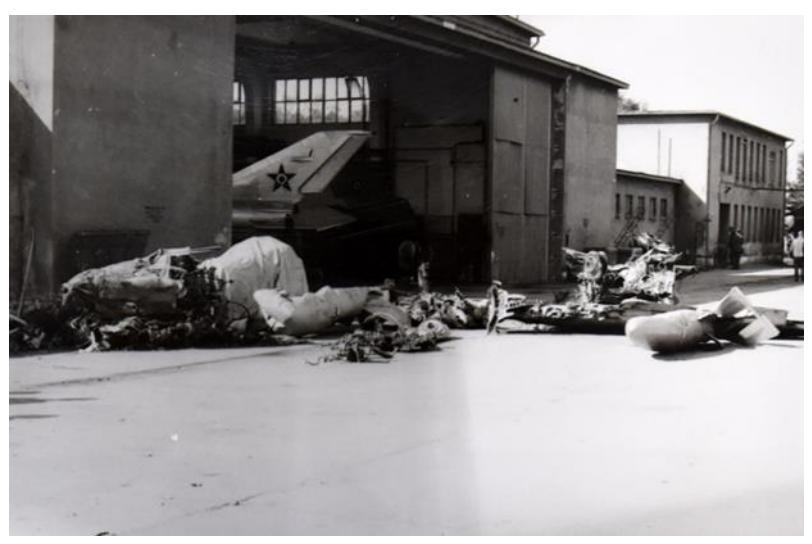
A meteorological balloon's parts can cause accidents as a whole or also separately. On 16th September 1970, a MiG-19PM supersonic fighter jet collided with a meteorological balloon. The pilot catapulted, surviving the accident. The aircraft crashed into ground at a village named Szágy in Hungary. On Fig. 2. the damaged parts of the aircraft are shown. [4]

Figure 2. The collected parts of the airplane [4]

At the moments of the collision the fighter flew at an altitude of 4,000 meters with a ground speed of 930-950 km/h. According to the results of the Hungarian People's Army's aircraft accident investigation report, the aircraft collided with a meteorological balloon. The radiosonde has been found 2125 meters from the crash site which was a Soviet production with Nr. 909-099510. It was launched by the Soviet Armed Forces' Southern Group of Forces formation in Hungary. At the

collision 5 m^3 hydrogen gas from the balloon exploded and damaged the aircraft leading to the crash. [4]

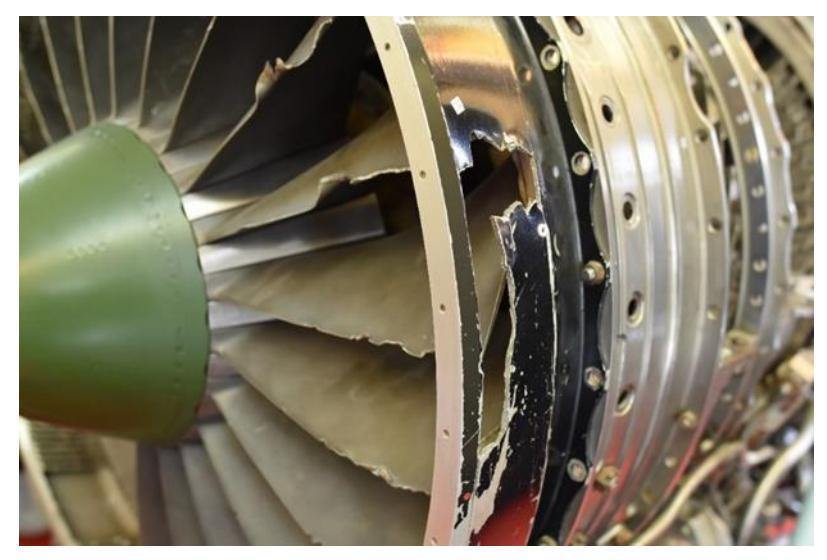
The radiosonde did not collide with the aircraft, but it could have. It could have been also absorbed by the jet engine, damaging it ending at least with an emergency landing. For visualization, an engine damage can be seen on Fig. 3. It has occurred by absorbing a mounting tool form ground.

Figure 3. A damaged turbofan engine

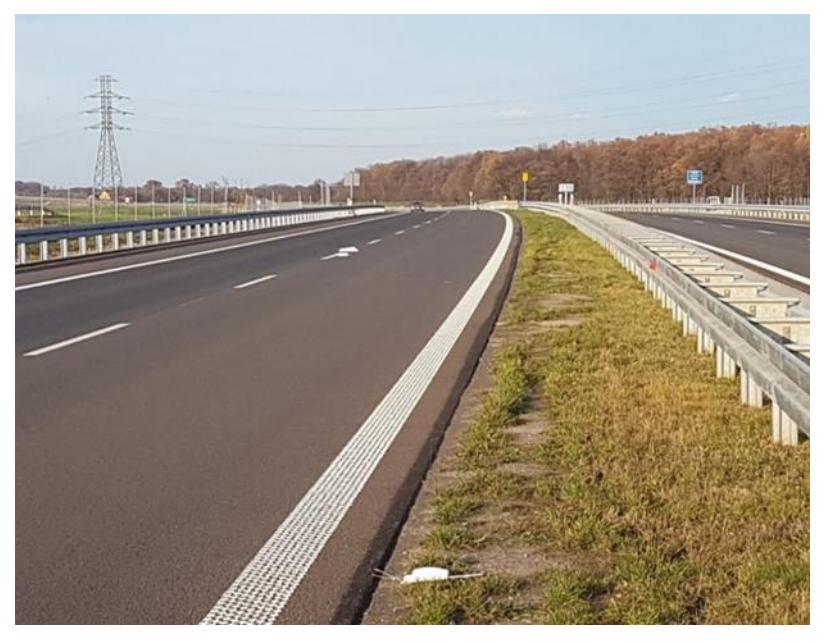
Meteorological balloons may also land on a street, country road or a motorway. A Vaisala RS41 radiosonde launched with Nr. R0920515 from Prague (in Czech Republic) landed on the S3 expressway near Wiadrów (in Poland) on 16th November 2019. On Fig. 4. the radiosonde can be seen on the edge of the road in the grass. [8]

Figure 4. The radiosonde on S3 expressway [9]

In the background a white patch can be seen in the middle of the expressway which is most probably the balloon. A thin rope more precisely a string is connecting the two parts, which can be identified as a thin white line on the original photo. On a video showing the collecting of meteorological balloon it can be seen clearly that no parachute was used. [10] This meteorological balloon had a 13m/s descent rate in the last half minute of its flight. [8] This 13m/s measurement data also confirms that the descent rate without or with not functioning parachutes can be above 8-10 m/s. Radiosondes landing with this speed can cause significant damages.

Landing on expressway or motorway could lead to dangerous situations or damages. If a radiosonde with a speed of 13 m/s and a car with a speed of 30.56 m/s (110 km/h) collided, the car would have a serious damage and the radiosonde would be most probably destroyed.

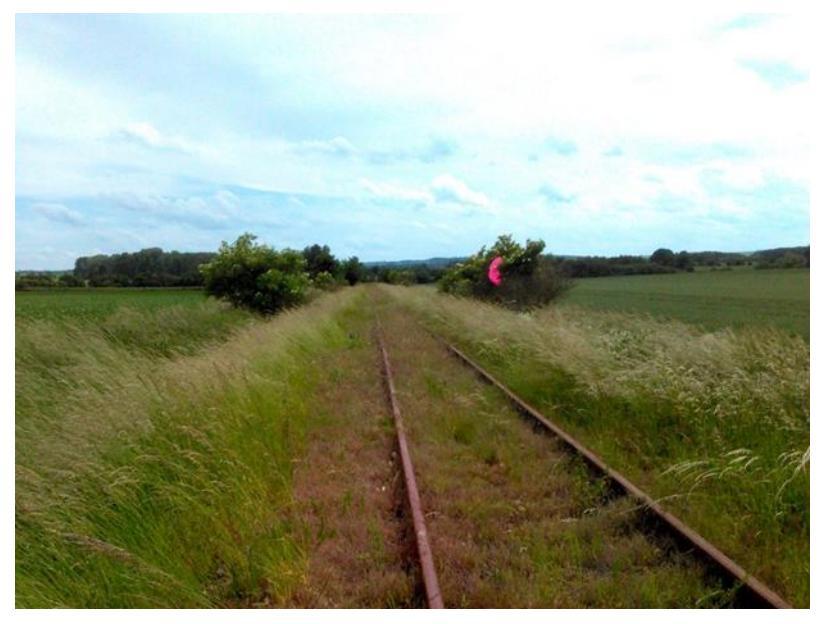
A light unmanned free balloon landed at a railway track near Svojšice village, in the Kolín District (in Czech Republic) on 2nd June 2015. The balloon was launched by N. Hegyi from Prague. As shown on Fig. 5. the track probably had not been used for some time.

Figure 5. Light unmanned free balloon landed at railway track

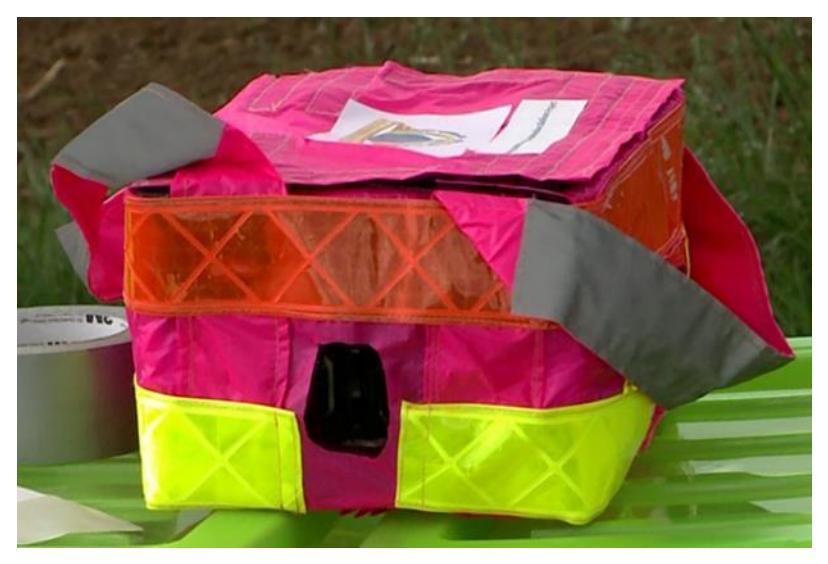
It was a private use balloon, but to be clear many of them were developed and launched previously. The payload was structurally an expanded polystyrene (EPS) box inside a magenta colored "plastic bag" combined with yellow and orange colored reflective surfaces for a better visibility. The material of the bag was a light polyester waterproof fabric. It had multiple tracking devices and a photo camera installed inside. It had two GoPro Hero3 cameras in special protective cases and a partially flexible antenna for 144.800 MHz Automatic Packet Reporting System tracking (APRS tracking) installed outside. The payload was connected to a magenta colored parachute made form the same material as the "bag" with a rope that required an impact force of less than 230 N to separate it from the balloon. This force is specified by Commission implementing regulation (EU) No 923/2012. [11]

Figure 6. The payload

A locomotive and the balloon's parts could collide in many different situations. The payload can land on the track, it can hang on the rope from a tree (directly or by swinging), or it can be fitted with a rope having a greater tensile strength also. In case of the last option the locomotive could capture the balloon or the parachute, drag the payload with itself and cause damages. If a train had collided directly into the payload's harder parts, such as the specially protected GoPro cameras, they could have caused damages in the front lamps or ruptures in the windshield of the locomotive. This leads to the conclusion that the above-mentioned payloads need an outside layer for collision reduction.

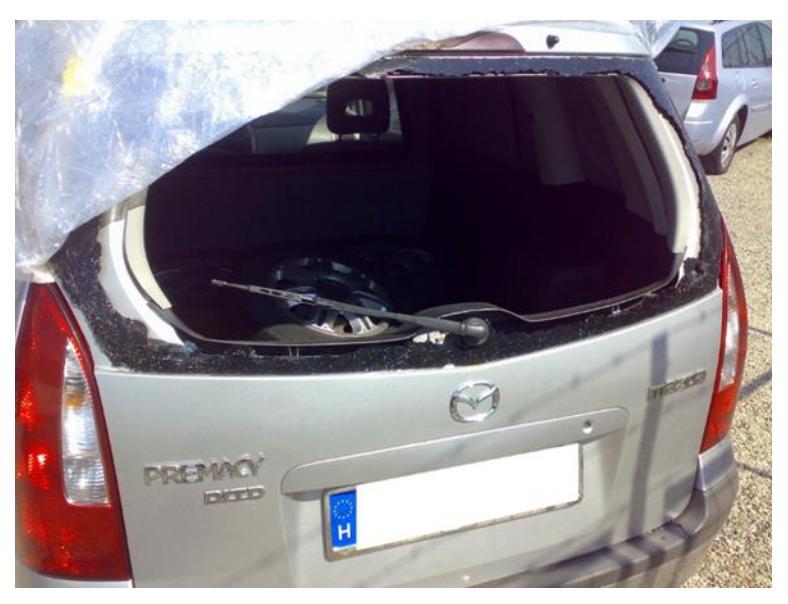
On 9th June 2011, the rear windshield of a parking Mazda Premacy car was broken by a Vaisala RS92-SGPW radiosonde as shown on Fig. 7.

Figure 7. Broken car window [12]

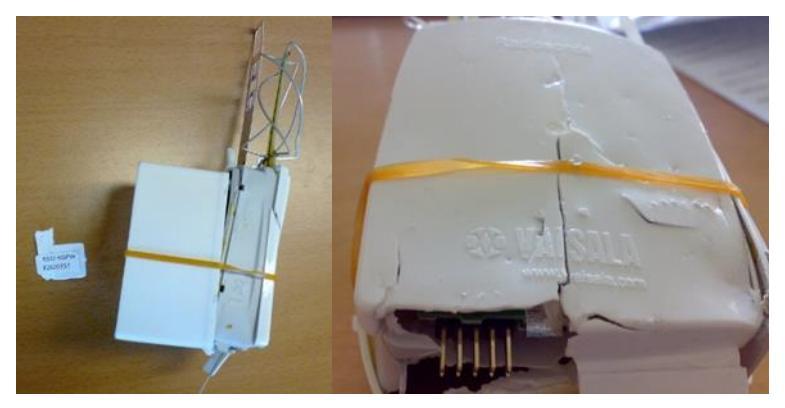
The radiosonde was launched form Szeged Meteorological Observatory. The accident occurred 2,2-2,4 km from the launch site. The fractured radiosonde is shown on Fig. 8. The device fell apart. It was broken in many places. For better understanding, the structure of the Vaisala RS92 type radiosondes have a plastic shell, inside with an EPS layer for insulation, two small liquid filled pieces for heat containing purpose and the electronic parts.

Figure 8. The broken radiosonde [12]

Their weight varies by model. There are versions of 160 g with lithium batteries and 280-290 g with alkaline batteries as well. [13] This radiosonde was a heavier model. It had a 14-15 m/s descent rate at landing. It had no parachute. It damaged a parking car. Thinking further, what could it have caused if it collided with a moving car? Although the Hungarian Meteorological Service replaced the usage of Vaisala RS92 radiosondes it needs to be stated that these models are still used by many meteorological institutes and services today.

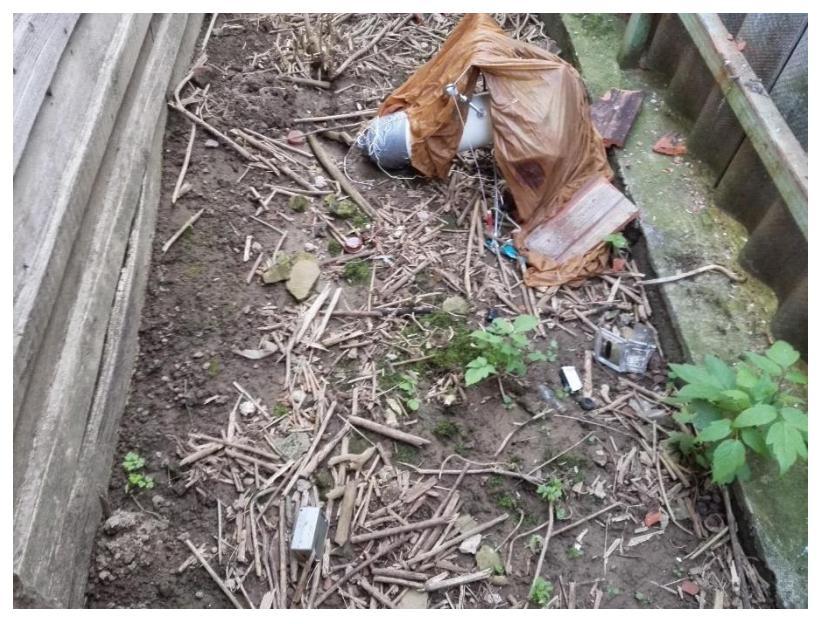
On 18th September 2014, an unmanned free balloon crashed into a building in Pánd village in Pest County (in Hungary). On Fig. 9. the crashed device can be seen, and it shows also the damage that has been caused to the building's roof tiles. It was a homemade balloon not complying with safety rules [14].

Figure 9. The sight of damage [14]

It is not clear what size the payload is, but an approximation from relative sizes can be calculated. Also, an approximation for the mass of the parts can be calculated by searching their weight or their density. After doing this work the conclusion is that it should be at least 4-6.5kg. There is also equipment inside the payload which cannot be seen from outside. From this it can be concluded that the probe is heavier, than the previously specified weight. As written in the previously mentioned European regulation [11] if the balloon fits a few regulations with less than 4 kg weight payload it can be categorized still as a light unmanned free balloon, with a payload 4 kg or more, but less than 6 kg it is in the medium category. But with 6.5 kg it is definitely a heavy free unmanned balloon.

The type of the balloon used for the flight is not known. Its material is most probably latex. Most of the easily available latex balloons are not produced to lift 6,5kg payloads for high altitude flights. But by calculating the needed filling volume for lifting the balloon with a heavy payload it can be proved, that there are products which would be usable for a flight lower than high altitudes. The conclusion is that the lifted weight of the analyzed payload may have exceeded 6.5 kg.

At the crash site the balloon and the payload were connected, which means their weight could have varied in a wide range. Assuming extra weight of nonvisible parts inside the payload, and assuming the probable weight of the balloon itself the calculated mass could be 5-10 kg.

On Fig. 9. the broken, fallen roof tiles can be seen. Most probably the metal made hard parts, such as the wire tensioners hit the roof most intense. Such hard parts may also have been installed if the payload was much lighter. This is one of the reasons to develop balloon payloads with a shock absorbing outer shell. It can be also concluded that homemade unmanned free balloons can be dangerous.
