# An Integrated Analysis of Aluminium Formwork Systems in Non-Standard Floor Plan Construction: Defectology, Labour Productivity and a BIM-Based Cost Estimation Model

**Abstract:** This paper presents a comprehensive case study of an 11-storey residential building constructed in Taipei, Taiwan, using an aluminium formwork system. The research establishes a detailed taxonomy of common concrete surface defects, quantifying their frequency and mapping their occurrence to specific structural elements. It was found that while defects are more prevalent in initial stages, a distinct learning curve leads to their reduction over successive floors. Secondly, this study analyses labour productivity, revealing that the Taiwanese construction team achieved an assembly rate of 5-7 m<sup>2</sup> per man-day, a figure that compares favourably with international benchmarks from India and Sri Lanka. Factors influencing this rate, including weather and geometric complexity, are examined. The primary contribution of this research is the development and validation of a novel labour estimation methodology. By leveraging Building Information Modelling (BIM), the study demonstrates that using a 'flat ar

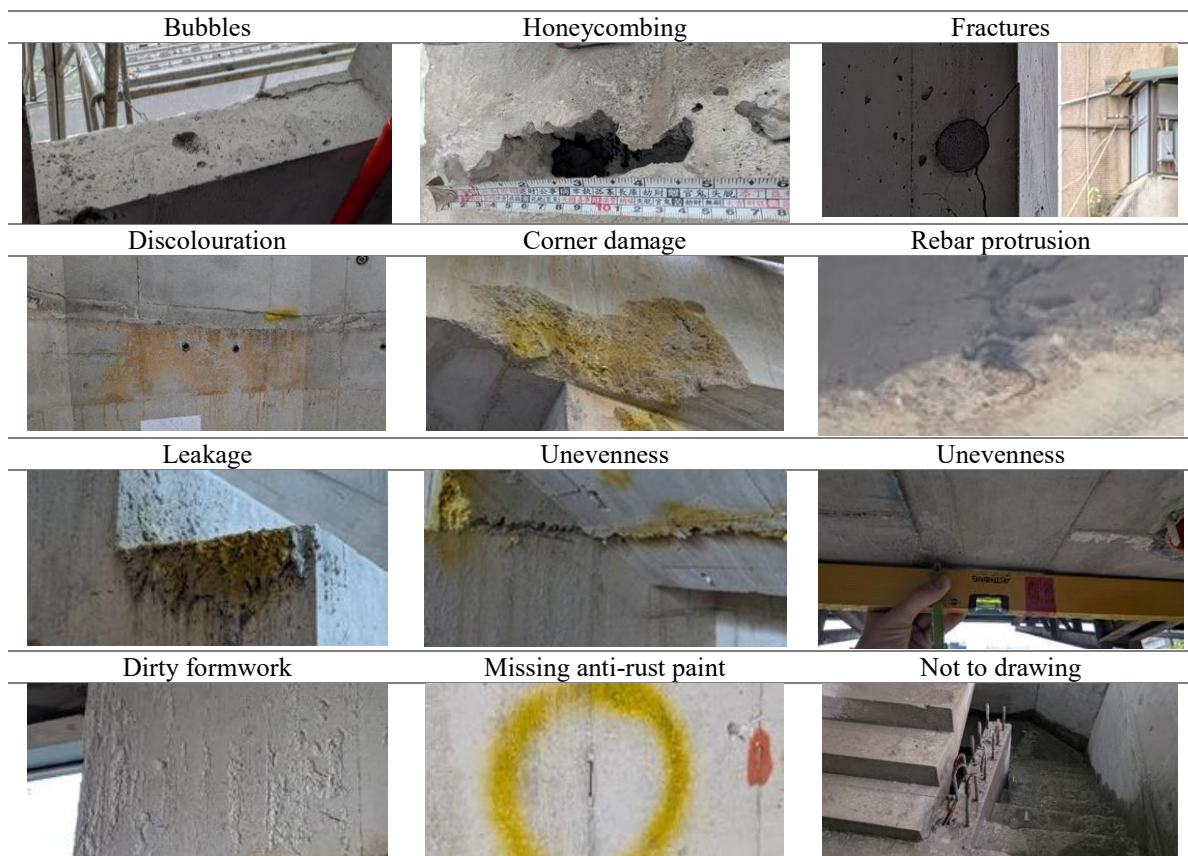
**Table 1.** Concrete surface defect examples

Following the removal of the aluminium formwork on each floor, a comprehensive visual inspection was conducted. Defects on the concrete surfaces of all structural elements were identified, photographed, and categorised [11]. Typical examples are shown in **Table 1**. The classification system was developed based on industry-standard terminology and the specific issues observed on site, resulting in the following eleven primary defect categories:

1. Bubbles: Small, shallow surface voids.
2. Honeycombing: Coarse, stony surfaces where mortar has failed to fill the spaces between coarse aggregate.
3. Fractures: Linear fractures of varying depth and length.

4. Discolouration: Inconsistent colouring or staining on the concrete surface.
5. Corner damage: Spalling or chipping of external corners of beams, columns, or walls.

6. Protrusion: Unwanted materials, such as tie rods or styrofoam, embedded in and protruding from the surface.
7. Leakage: Fins or marks left by cement grout seeping through joints between formwork panels.

8. Unevenness: Deviations from a true plane, including both localised bumps/depressions and larger-scale differences in level.
9. Dirty formwork: Surface imperfections and textures caused by unclean formwork panels.

10. Missing paint: missing anti-corrosion paint on the metal formwork ties.
11. Not to drawing: construction not according to the drawing.
